## Annual Inspection

Fields in Trust - (NPFA)

Norton in Hales

Bearstone Road, Shropshire, TF9 4AP

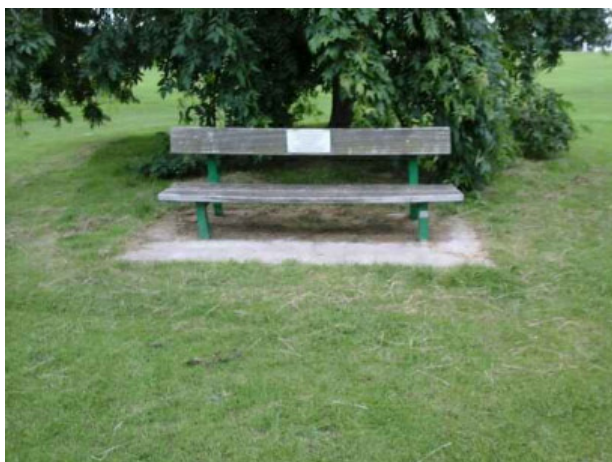
**Item:** Ancillary Items - Bench  
**Manufacturer:** Owner/Operator  
**Surface Type:** N/A  
**Equipment Compliance:** N/A  
**Surface Area Compliance:** N/A  
**Ref/Part Number:**  
**Total Findings:** 1

This item is satisfactory - no work required

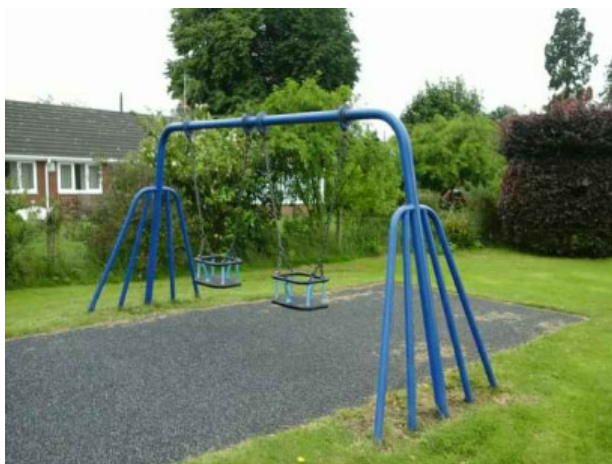
**Item:** Swings - 1 Bay 2 Seat (Cradle)  
**Manufacturer:** Wicksteed Playgrounds  
**Surface Type:** Wet Pour  
**Equipment Compliance:** Yes  
**Surface Area Compliance:** Yes  
**Ref/Part Number:**  
**Total Findings:** 1

The shackles are corroding - Monitor for any further deterioration and replace as required

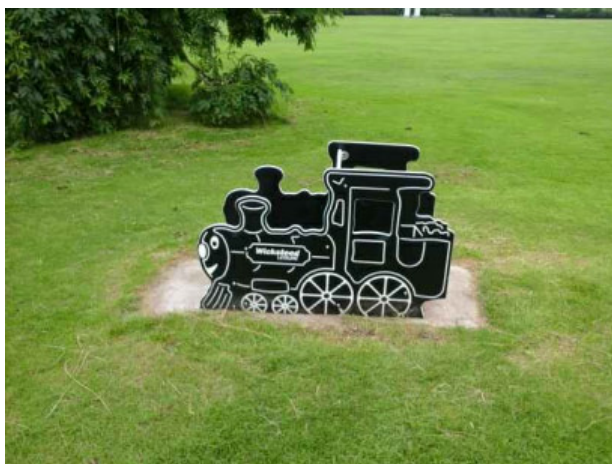
**Item:** Activity Equipment - Train  
**Manufacturer:** Wicksteed Playgrounds  
**Surface Type:** Concrete  
**Equipment Compliance:** Yes  
**Surface Area Compliance:** Yes  
**Ref/Part Number:**  
**Total Findings:** 1

There is or are fixings missing on the floor plate - Replace all missing fixings

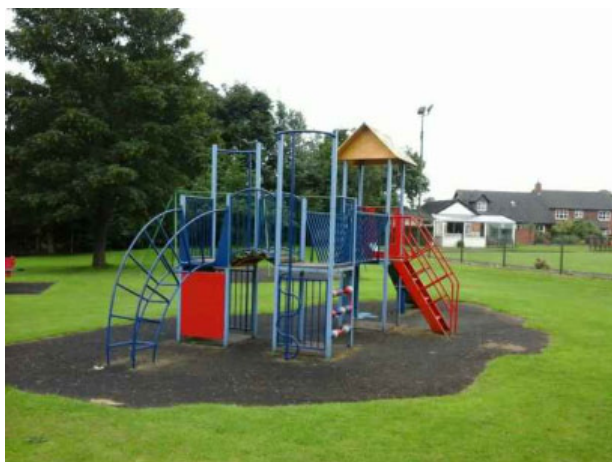
**Item:** Activity Equipment - Multi Play (Junior)  
**Manufacturer:** Wicksteed Playgrounds  
**Surface Type:** Wet Pour  
**Equipment Compliance:** No  
**Surface Area Compliance:** Yes  
**Ref/Part Number:**  
**Total Findings:** 8

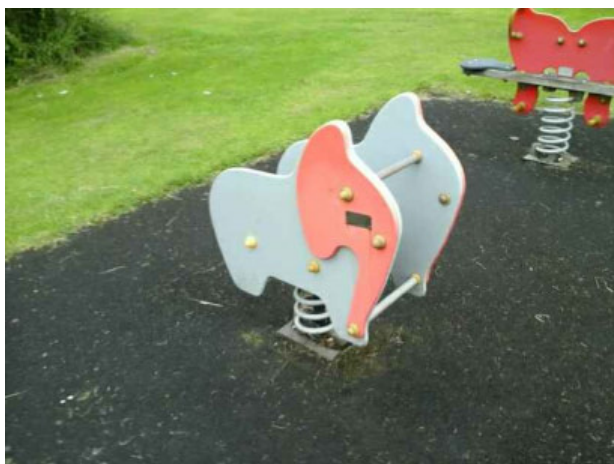
**Item:** Rocking Equipment - Spring Elephant  
**Manufacturer:** Wicksteed Playgrounds  
**Surface Type:** Wet Pour  
**Equipment Compliance:** Yes  
**Surface Area Compliance:** Yes  
**Ref/Part Number:**  
**Total Findings:** 2

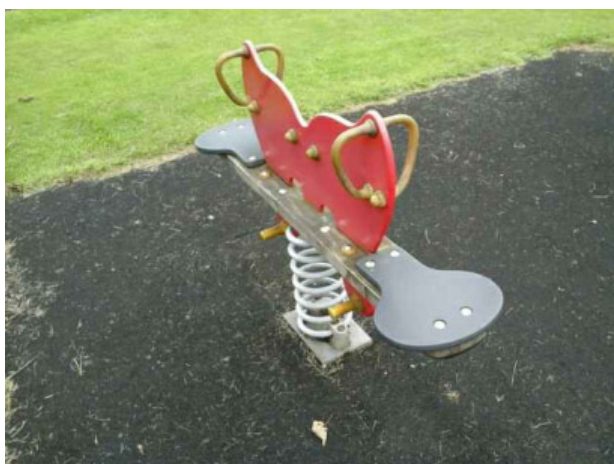
**Item:** Rocking Equipment - Spring See-Saw  
**Manufacturer:** Wicksteed Playgrounds  
**Surface Type:** Wet Pour  
**Equipment Compliance:** No  
**Surface Area Compliance:** Yes  
**Ref/Part Number:**  
**Total Findings:** 3

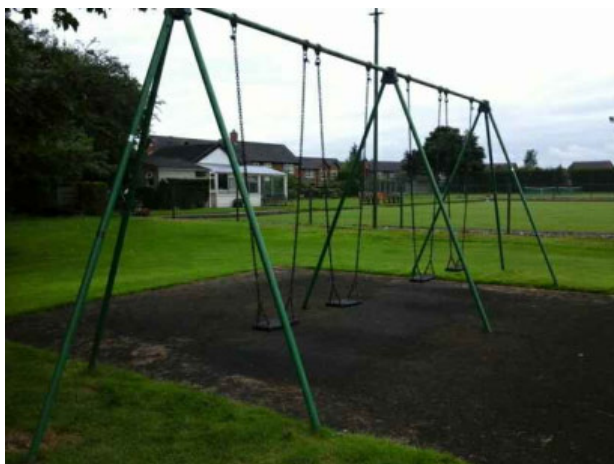
**Item:** Swings - 2 Bay 4 Seat (Flat)  
**Manufacturer:** Wicksteed Playgrounds  
**Surface Type:** Wet Pour  
**Equipment Compliance:** No  
**Surface Area Compliance:** Yes  
**Ref/Part Number:**  
**Total Findings:** 6

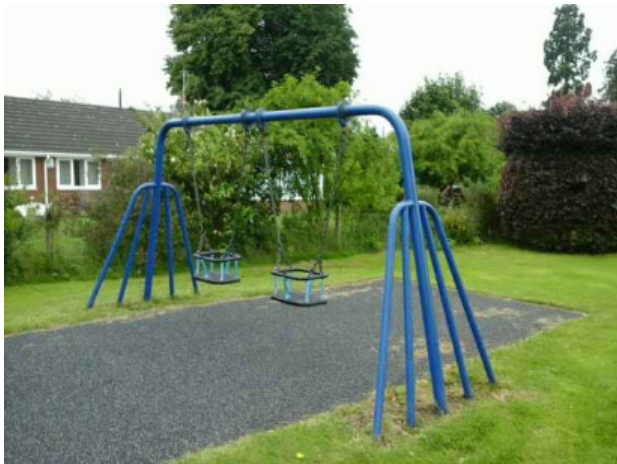
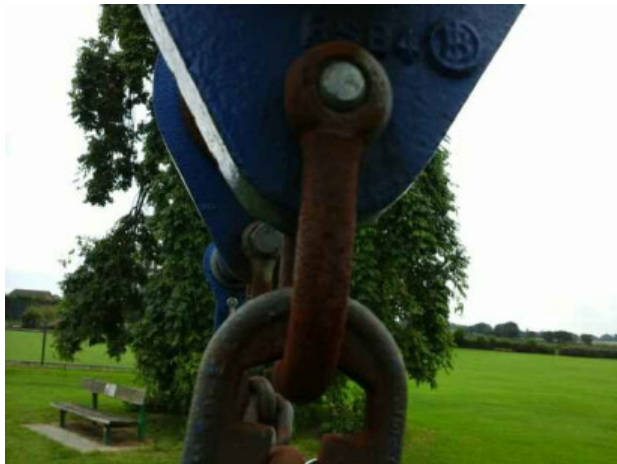
6 - Low Risk (Finding 1)			
<b>Item:</b>	Swings - 1 Bay 2 Seat (Cradle)	<b>Risk Level:</b>	L - Low Risk
<b>Manufacturer:</b>	Wicksteed Playgrounds	<b>Surface:</b>	Wet Pour

<b>Finding:</b>	The shackles are corroding		<b>Action:</b> Monitor for any further deterioration and replace as required

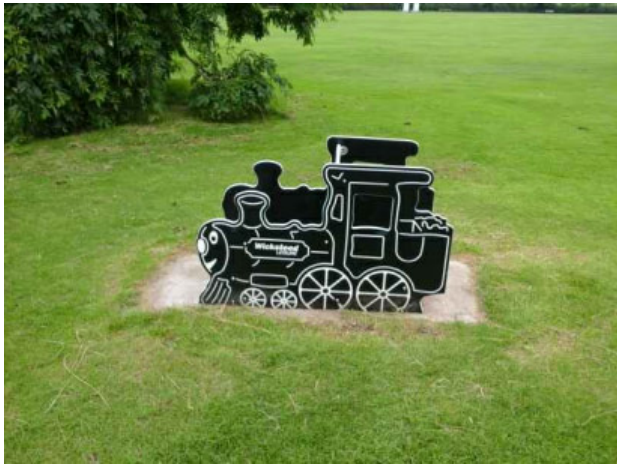
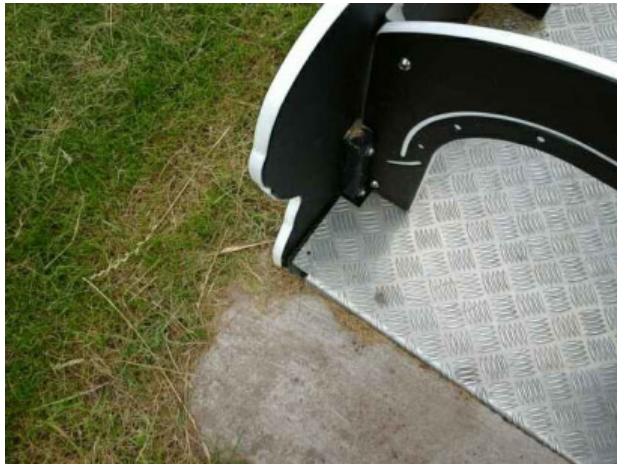
6 - Low Risk (Finding 1)			
<b>Item:</b>	Activity Equipment - Train	<b>Risk Level:</b>	L - Low Risk
<b>Manufacturer:</b>	Wicksteed Playgrounds	<b>Surface:</b>	Concrete

<b>Finding:</b>	There is or are fixings missing on the floor plate		<b>Action:</b> Replace all missing fixings

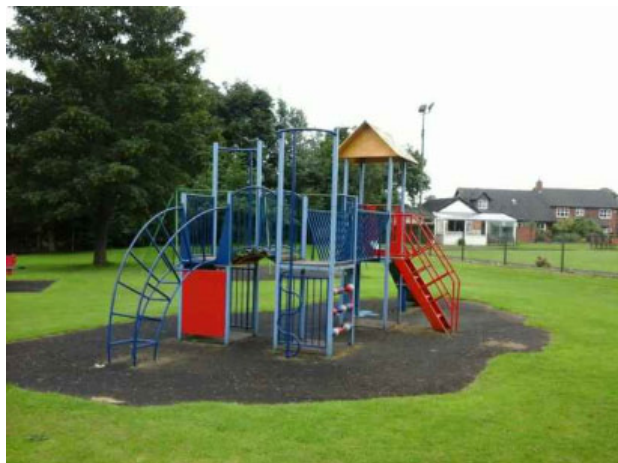
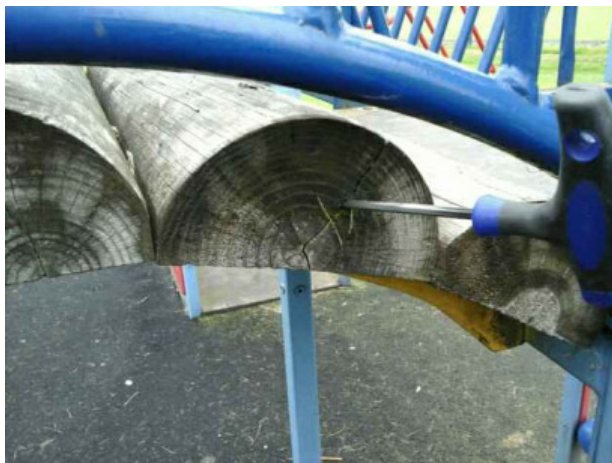
## 6 - Low Risk (Finding 1)

**Finding:** There is evidence of rot in the ends of the timber bridge sections

**Action:** Monitor for any further deterioration and replace as required

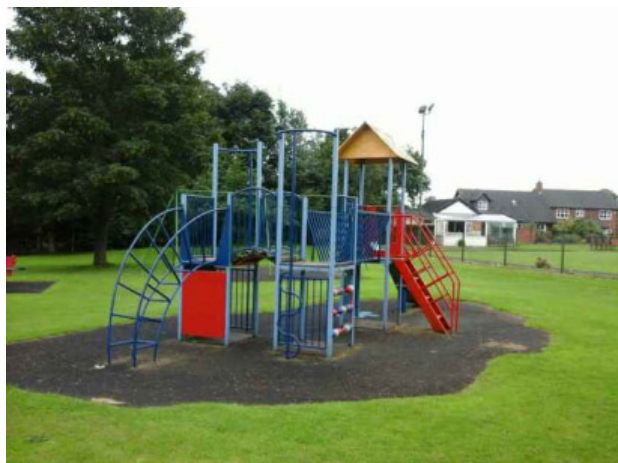
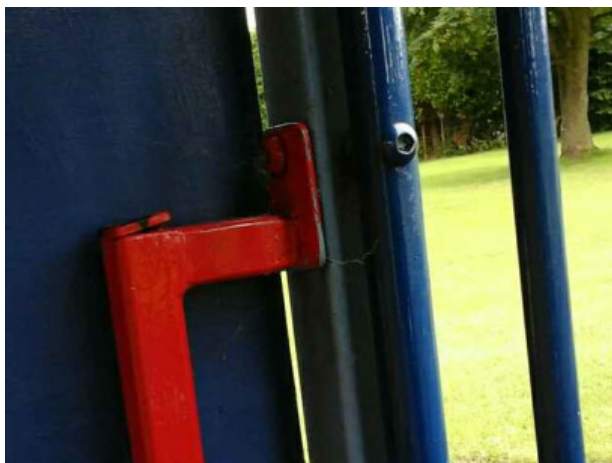
## 6 - Low Risk (Finding 2)

**Finding:** A number of fixing(s) have worked loose

**Action:** Secure all loose fixings

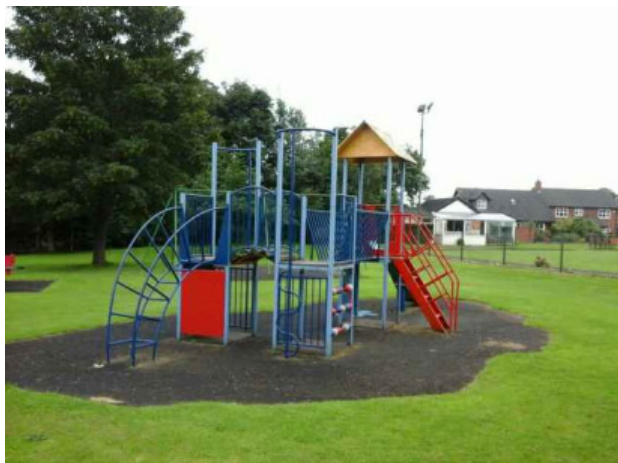
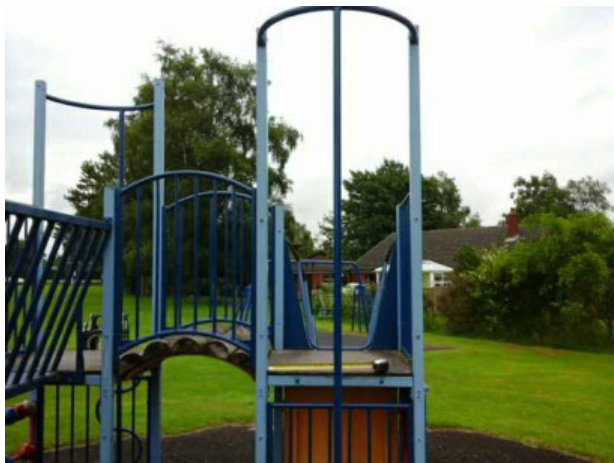
#### 4 - Very Low Risk (Finding 3)

**Finding:** There is an opening in the barriers exceeding the width allowed in BS EN 1176:2008, this is a low risk failure and no remedial action is required

**Action:** Monitor use

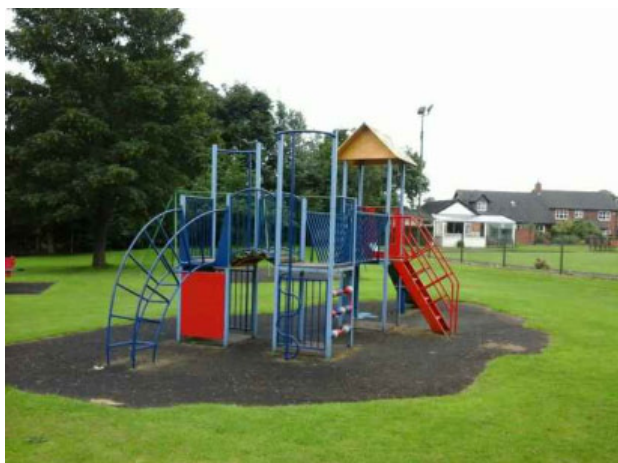
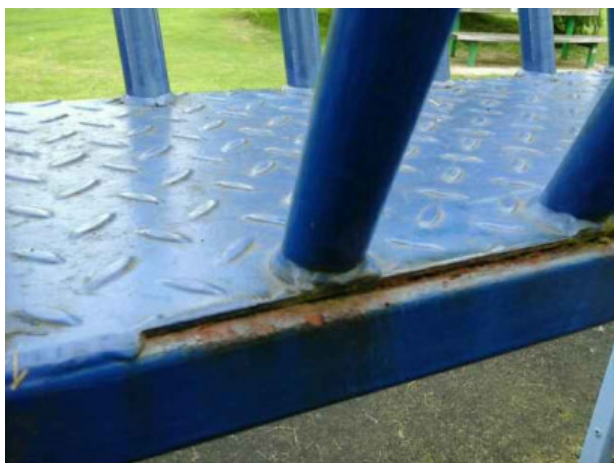
#### 6 - Low Risk (Finding 4)

**Finding:** There is surface corrosion present on the item

**Action:** Consider treating and repainting the item

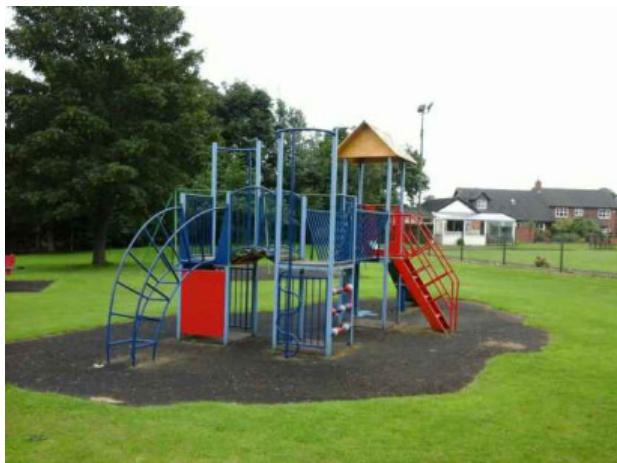
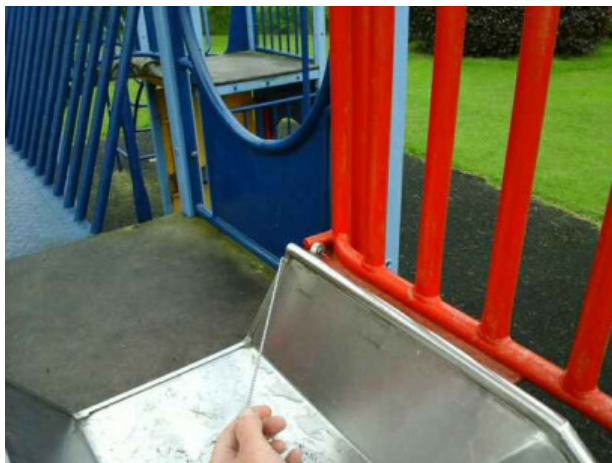
### 5 - Very Low Risk (Finding 5)

**Finding:** There is a toggle entrapment at the top of the slide  
**Action:** Monitor Use

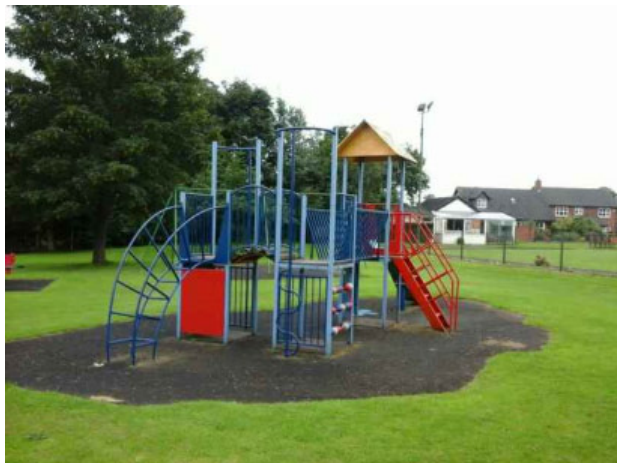
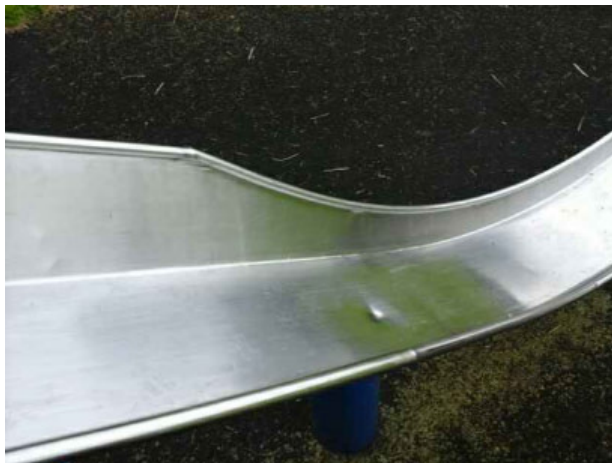
### 6 - Low Risk (Finding 6)

**Finding:** There are a number of dents in the slide surface  
**Action:** Monitor for any further deterioration and repair as required

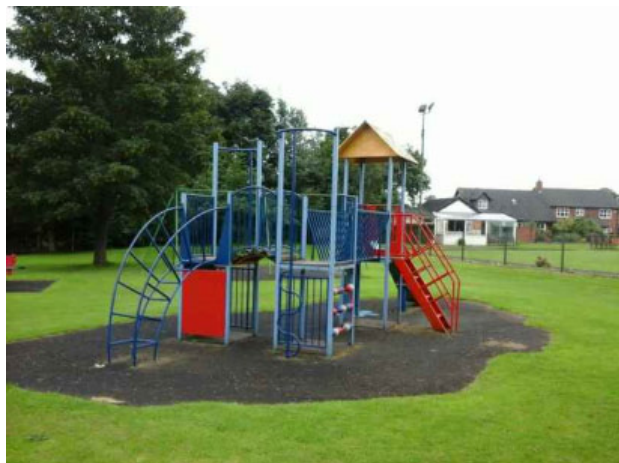
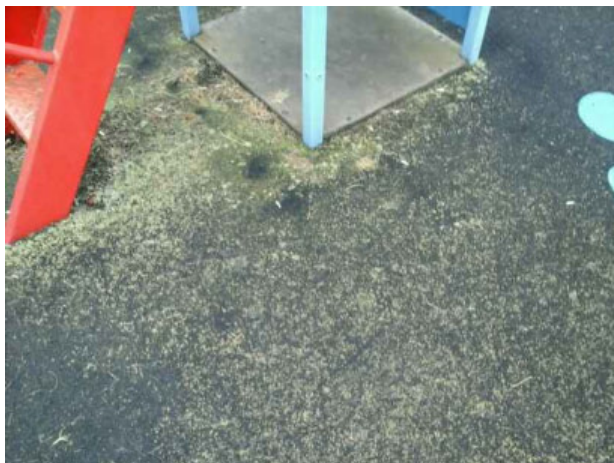
#### 8 - Low Risk (Finding 7)

**Finding:** There is algae or moss growth on the surface resulting in slippery conditions  
**Action:** Clean and treat appropriately

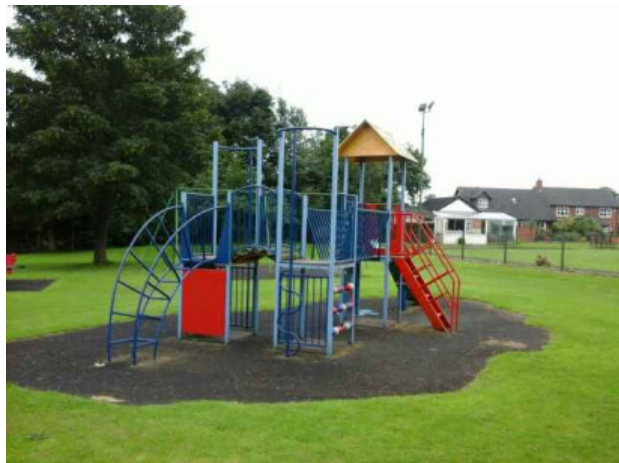
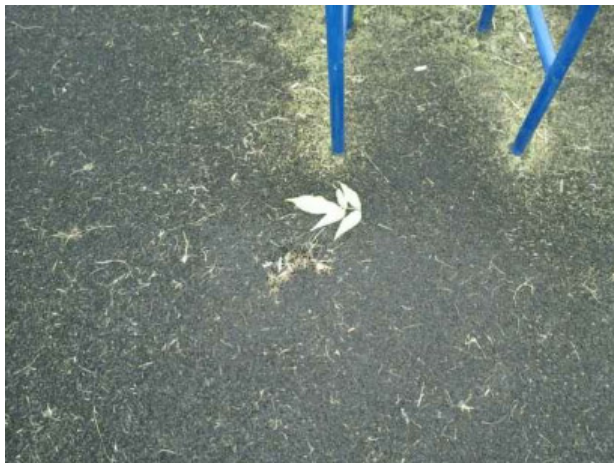
#### 4 - Very Low Risk (Finding 8)

**Finding:** The safety surface under or around this unit has been damaged  
**Action:** Monitor for any further deterioration and repair as required

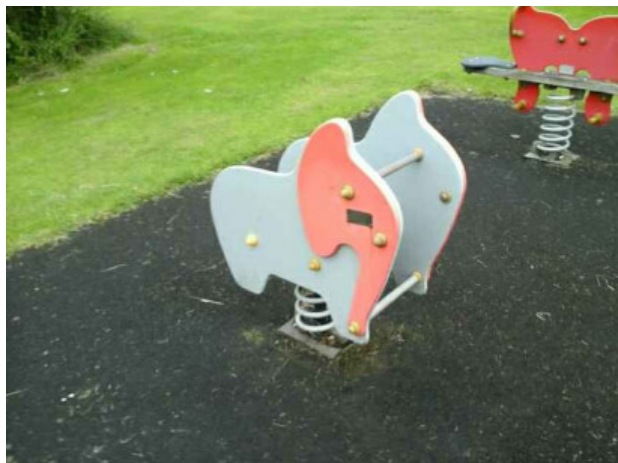
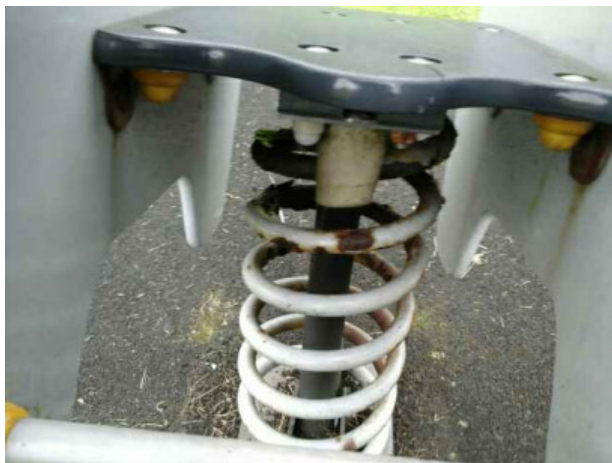
## 6 - Low Risk (Finding 1)

**Finding:** The paintwork on the spring has been damaged or worn exposing the metal underneath which is rusting

**Action:** Treat any rusting components and repaint

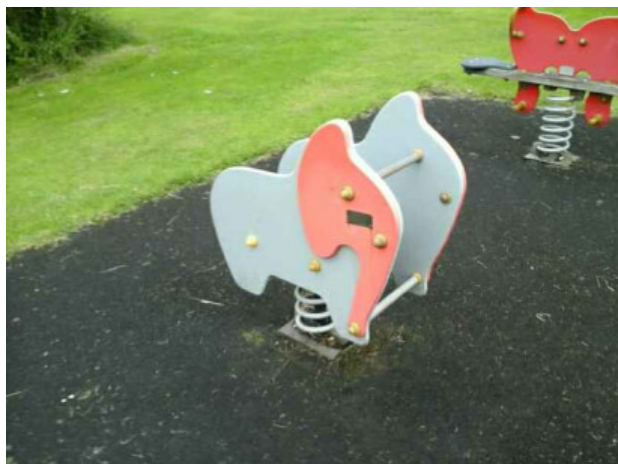
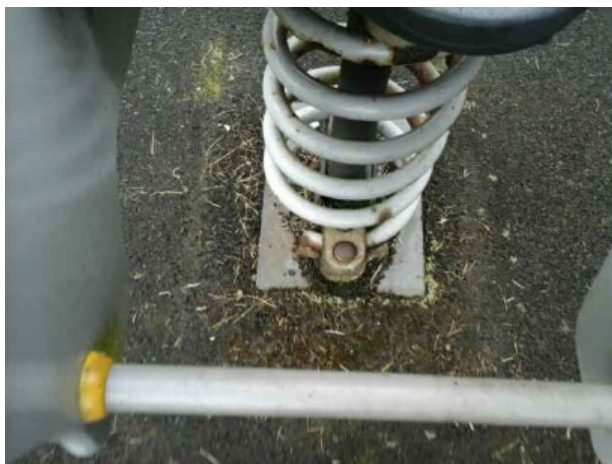
## 6 - Low Risk (Finding 2)

**Finding:** The U bolts clamping the spring are worn

**Action:** Monitor for any further deterioration and replace as required

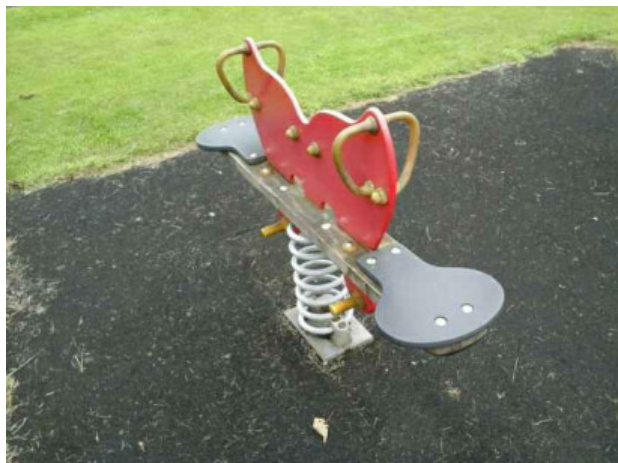
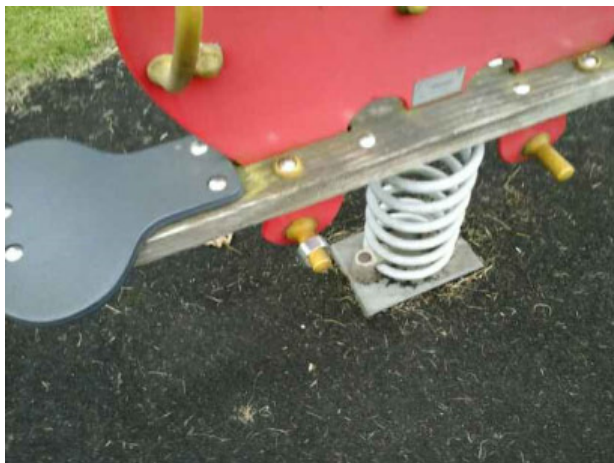
#### 4 - Very Low Risk (Finding 1)

**Finding:** The end of handgrips and/or footrests have a cross section of less than 15cm<sup>2</sup> and fail to meet the requirements of BS EN 1176:2008 Part 6

**Action:** This is a relatively low risk failure and no remedial action is recommended

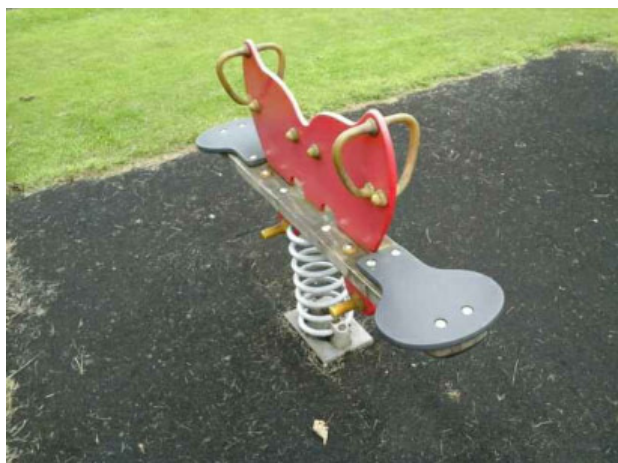
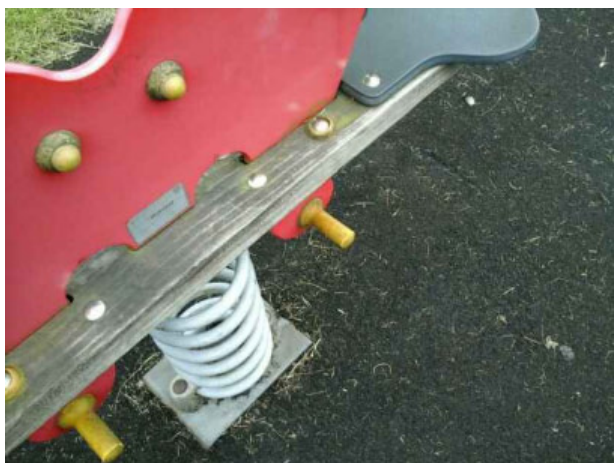
#### 6 - Low Risk (Finding 2)

**Finding:** The Handgrips/Footrests rotate and may cause an unexpected movement for the user

**Action:** Secure Handgrips/Footrests to prevent rotation.

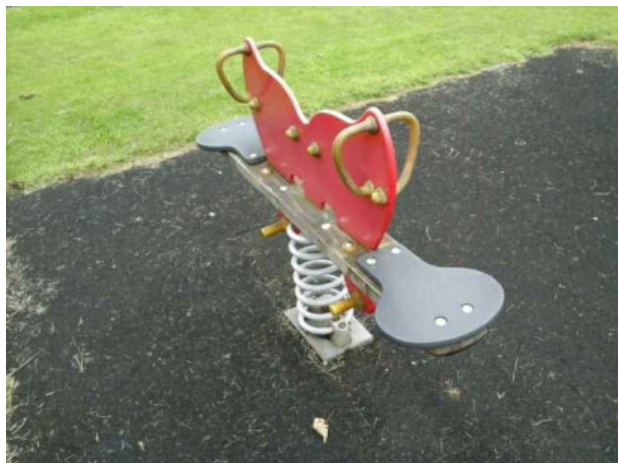
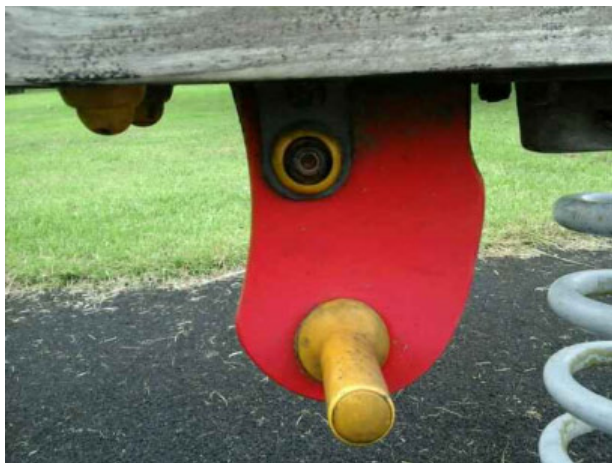
### 6 - Low Risk (Finding 3)

**Finding:** There is/are bolt cap covers missing or damaged on the item

**Action:** Replace missing or damaged bolt cap covers

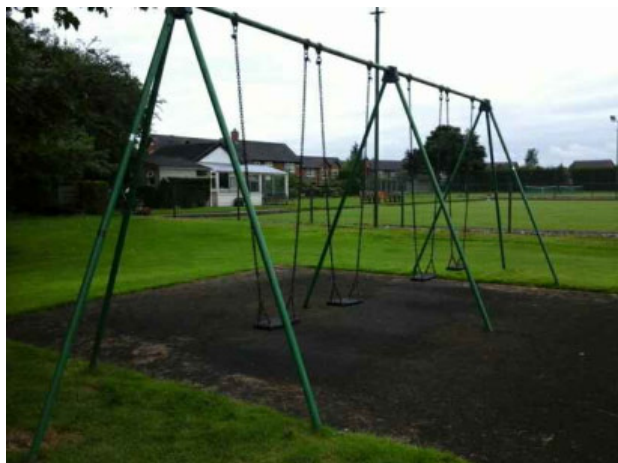
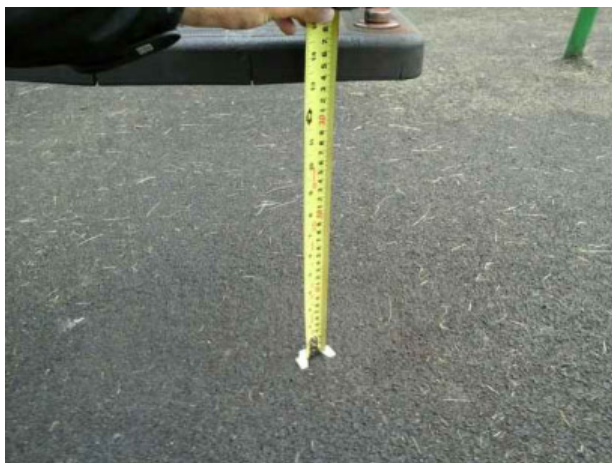
### 8 - Low Risk (Finding 1)

**Finding:** The seat clearance from finished surface level to the underside of the seat is too low.

**Action:** Install swing seats to a minimum height of 350mm to the underside of the seat for Flat and Cradle Seats. (A height of 400mm-500mm is recommended)

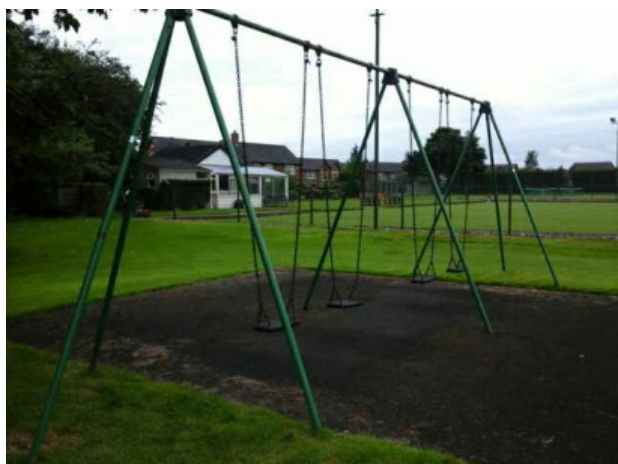
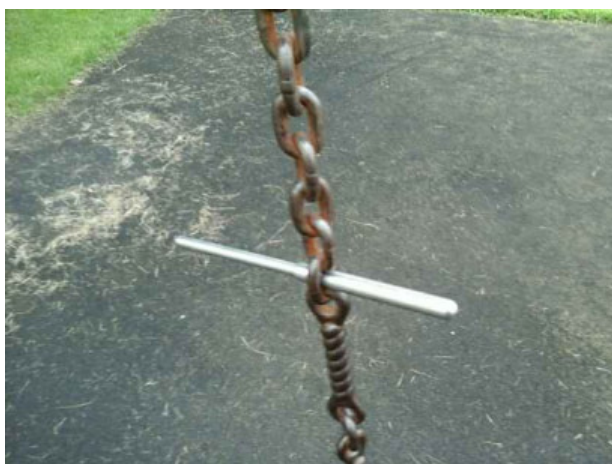
#### 4 - Very Low Risk (Finding 2)

**Finding:** The chain openings are in excess of the 8.6mm as recommended by BS EN 1176

**Action:** Monitor use and replace with compliant chains during next maintenance cycle.

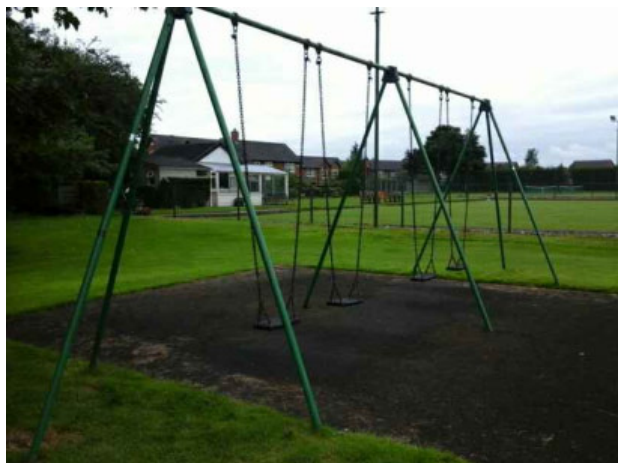
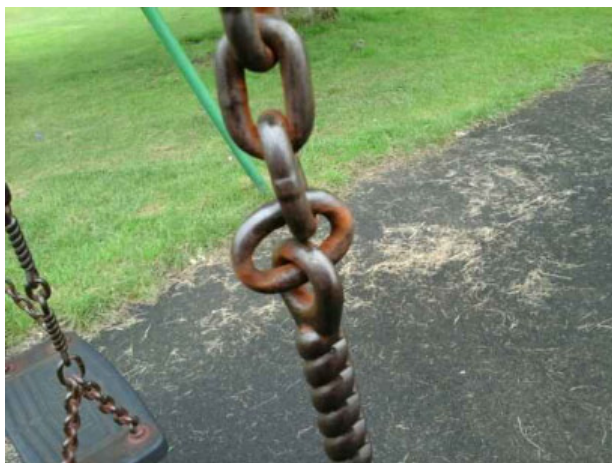
#### 6 - Low Risk (Finding 3)

**Finding:** There is some chain wear

**Action:** Monitor for any further deterioration and replace when 40% worn

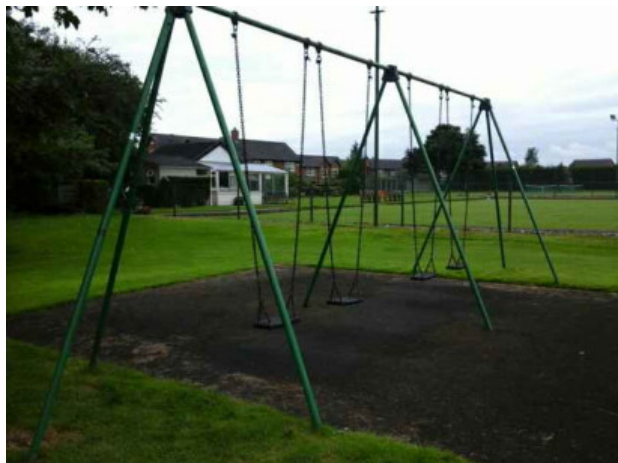
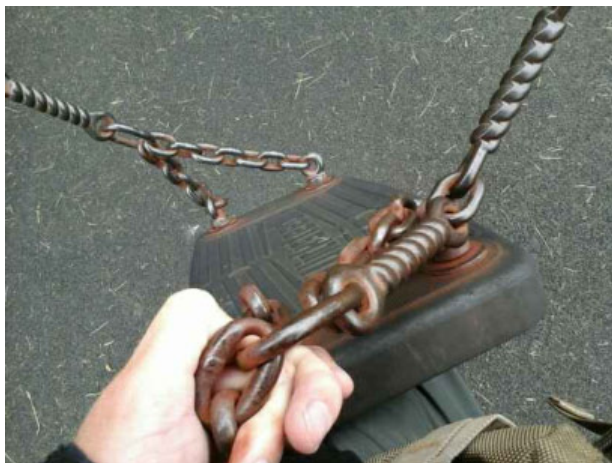
## 8 - Low Risk (Finding 4)

**Finding:** The chain links are worn in excess of 40% and require renewing

**Action:** Replace worn chains

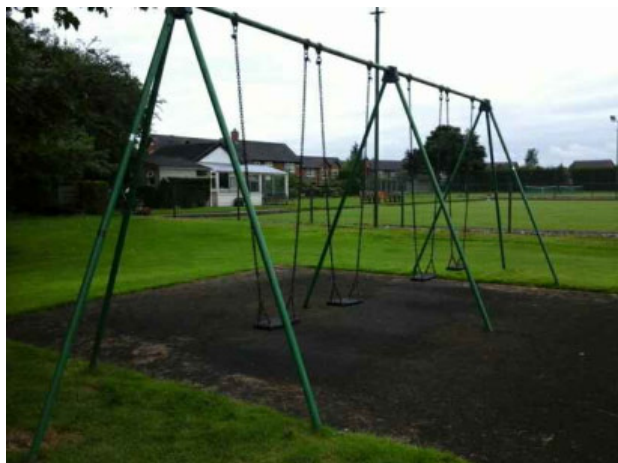
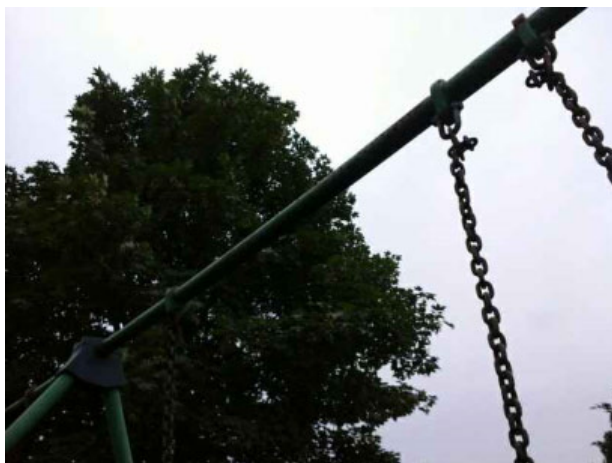
## 6 - Low Risk (Finding 5)

**Finding:** There is surface corrosion present on the item

**Action:** Consider treating and repainting the item

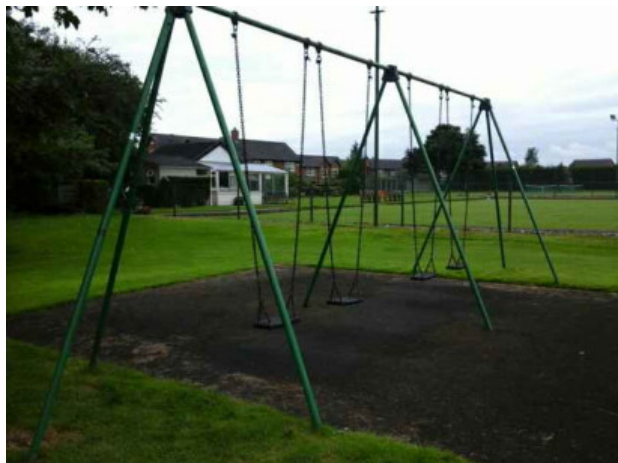
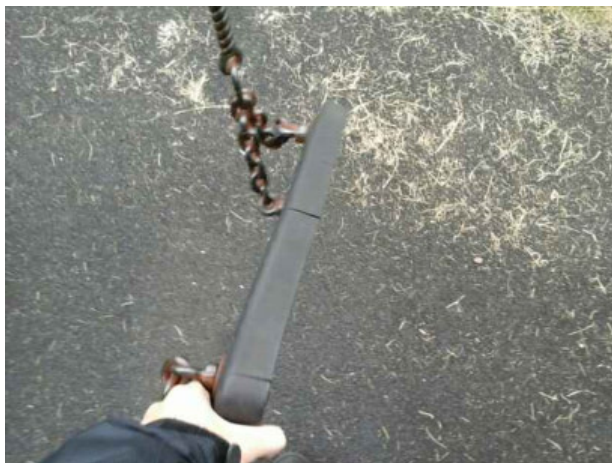
## 6 - Low Risk (Finding 6)

**Finding:** The seats are perishing

**Action:** Monitor for any further deterioration and replace as required
